SERVICE BULLETIN

FEBRUARY 1995

PRODUCT RECALL: TIPS™ FUEL CAP

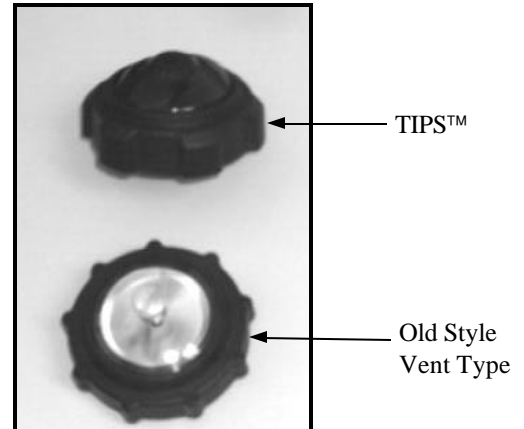
TIPS™: **Part#01080**

The fuel cap develops a leak during operation. Fuel spurts straight up (1 to 2 inches) from center vent hole. The spillage gets worse when temperature increases.

The new style TIPS™ cap is design to prevent spillage if kart is turned upside down. It does this job very well, but when operated under normal conditions, fuel is forced into cap from movement of kart around track. When fuel gets inside cap, fuel stays in and the only place for it to go is out

Replace TIPS™ cap with old version type fuel cap.
Return defective caps when you receive new ones.
