SERVICE BULLETIN

Thunder-02

Trim Update

ThunderBolt go-karts sold between December 1, 1995 to January 6, 1996

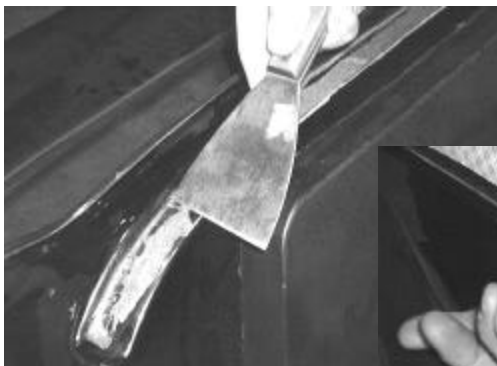
Movement of roof causing roof trim to pull away from body.

Step 1: Clean surface.
