J&J Amusements, Inc.

SERVICE BULLETIN

GO-KART # 3

AFFECTED UNIT- 1993 Black Frame Single and Double Seater GoKarts.

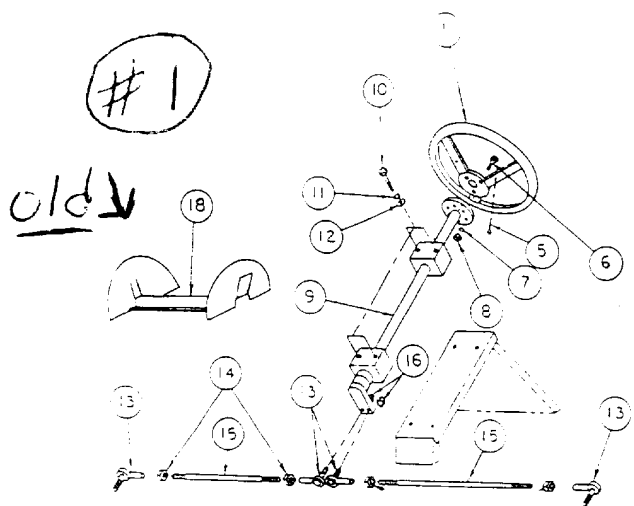
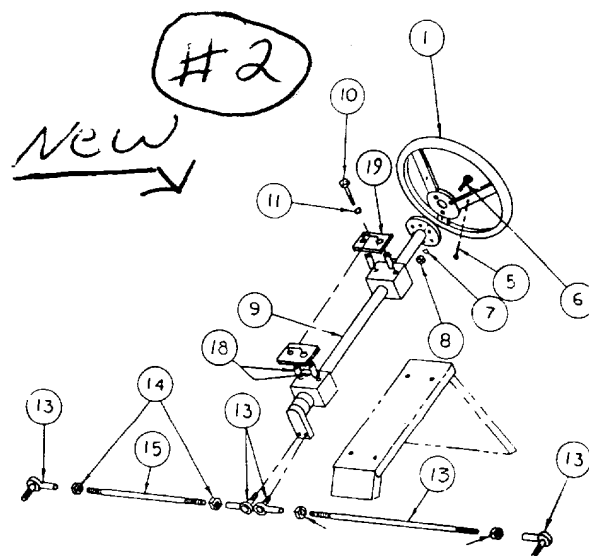
REASON FOR UPDATE- The bolts that hold the steering shaft are working loose resulting in poor handling of the gokart and/or breakage of the bolts.

1. Remove steering wheel (#1) from old steering shaft.
2. Remove steering cover (#18).
3. Remove nuts (#16), then remove tie rod ends (#13) from steering shaft.
4. Remove bolts (#10) and washers (#11 & 12). Next remove old steering shaft.
5. Install the updated steering shaft with the new hardware supplied (See Diagram #2) in the reverse order.

CORRECTIVE ACTION- Install new steering shaft and hardware. Follow the installation instruction below.

NOTE: USE RED THREAD LOCK ON BOLTS (#10) WHEN INSTALLING.
